**SOUTHWESTERN COASTAL BASIN  
GREENWICH, CONNECTICUT**

**AMERICAN FELT DAM  
CT 00043**

**PHASE 1 INSPECTION REPORT  
NATIONAL DAM INSPECTION PROGRAM**

**FEBRUARY, 1980**

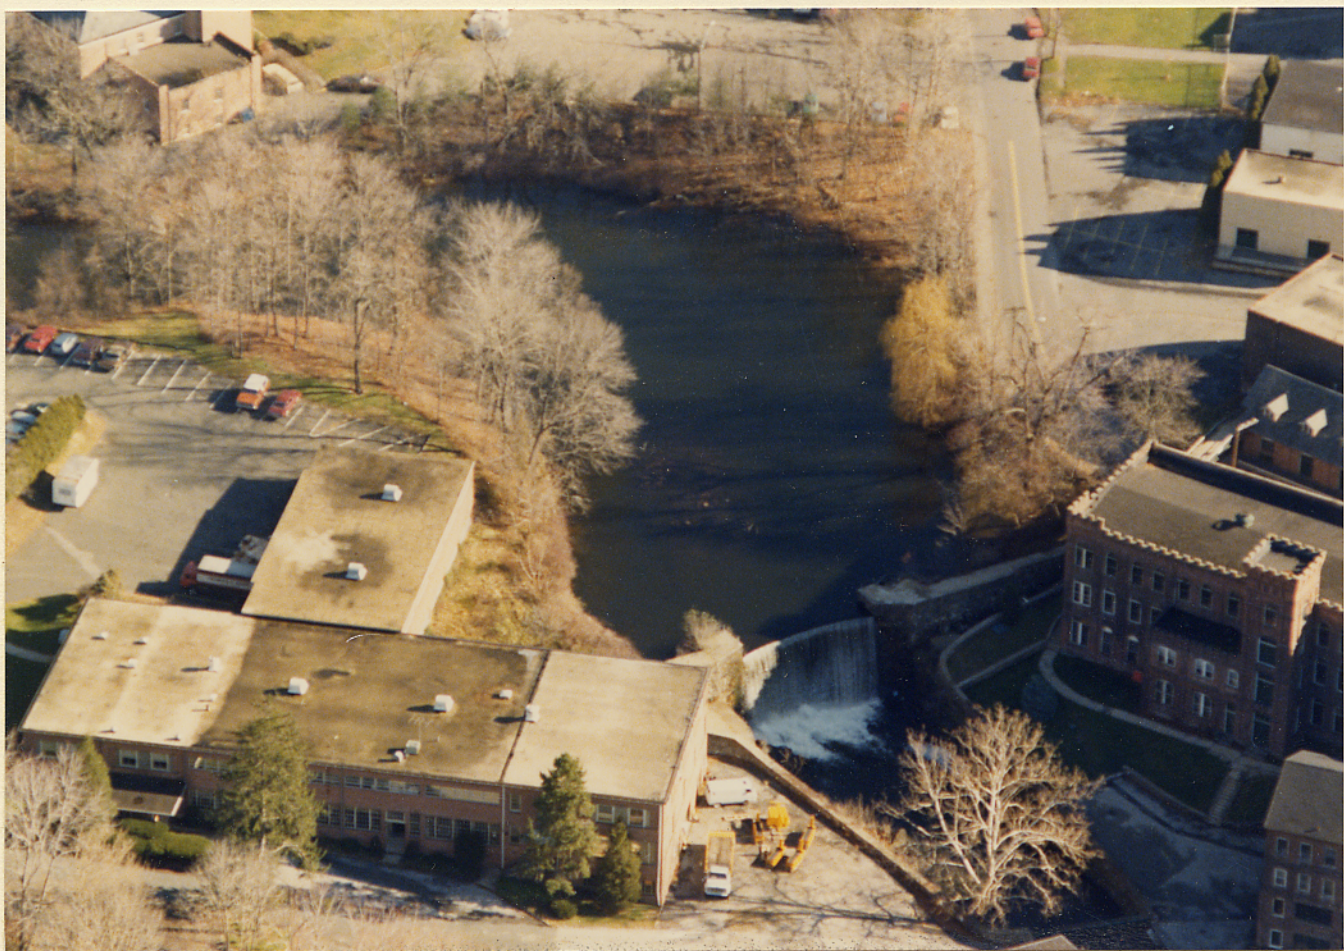
OVERVIEW PHOTO - AMERICAN FELT DAM

Based on the visual inspection and past operational performance, the dam is judged to be in FAIR condition. Seepage was noted on the downstream face. Both faces are vegetated and in need of repointing, and a few stones are missing from the dam at the ends of the spillway.

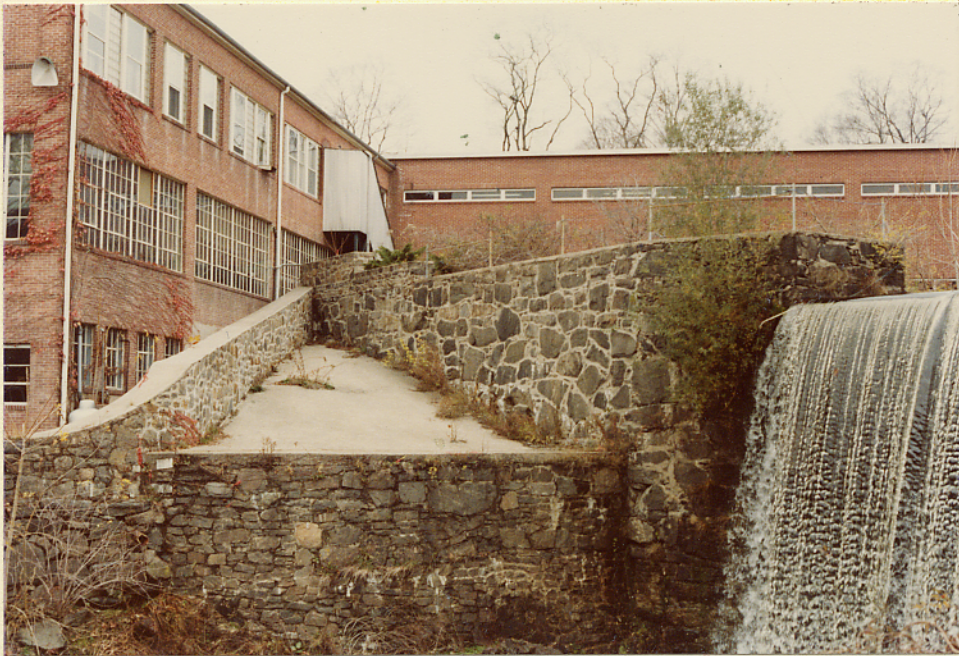
C-7 WEST OVERFLOW CHANNEL

Overflow channels were constructed in about 1955 just downstream of the dam to channel water flowing over the dam during flood conditions back to the river. The east channel existed prior to 1938 but was improved in 1955. The channels consist of a masonry wall downstream of the dam and a paved (concrete) invert (Photos C-7, 8). Grass and small shrubs are growing from cracks in the concrete and between the stones.
